ANALYSIS AND TESTING OF A METALLIC REPAIR APPLICABLE TO PRESSURIZED COMPOSITE AIRCRAFT STRUCTURE

ABSTRACT

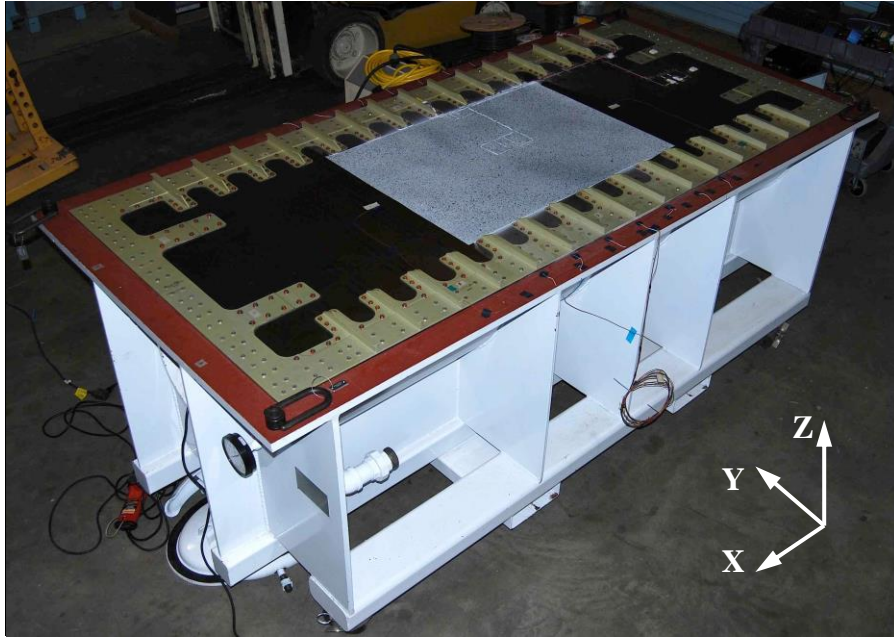
The pristine pressure panel installed on a steel pressure vessel is shown in Figure 5. The outer dimensions of the panel were 2.74 m by 1.22 m (108 in. by 48 in.). The opening in the top of the pressure vessel was 2.54 m by 1.02 m (100 in. by 40 in.) so that a width of 0.102 m (4 in.) around the perimeter of the panel was clamped. It is seen in Figure 5 that the installation fixture

Figure 5. Pressure vessel with the pristine test panel installed.

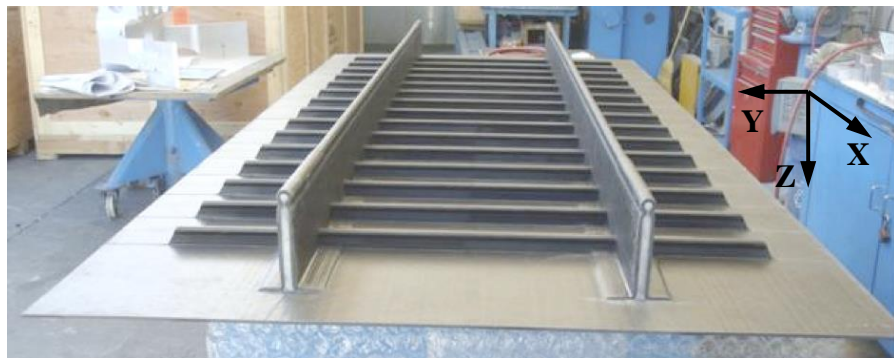
additionally extended toward the center of the panel over the two frame caps (in the X-direction) and 15 stringer flanges (in the Y-direction). The stiffened side of the panel before installation to the pressure vessel is shown in Figure 6, where the aforementioned frame caps and stringer flanges are visible. Stiffener geometry and spacing are the same as for the tension panel. Material properties of the panel and metallic repair installed after the panel sustained damage in the initial testing are listed in Table 1.

Figure 6. Stiffened side of the pressure panel before installation onto the pressure vessel.

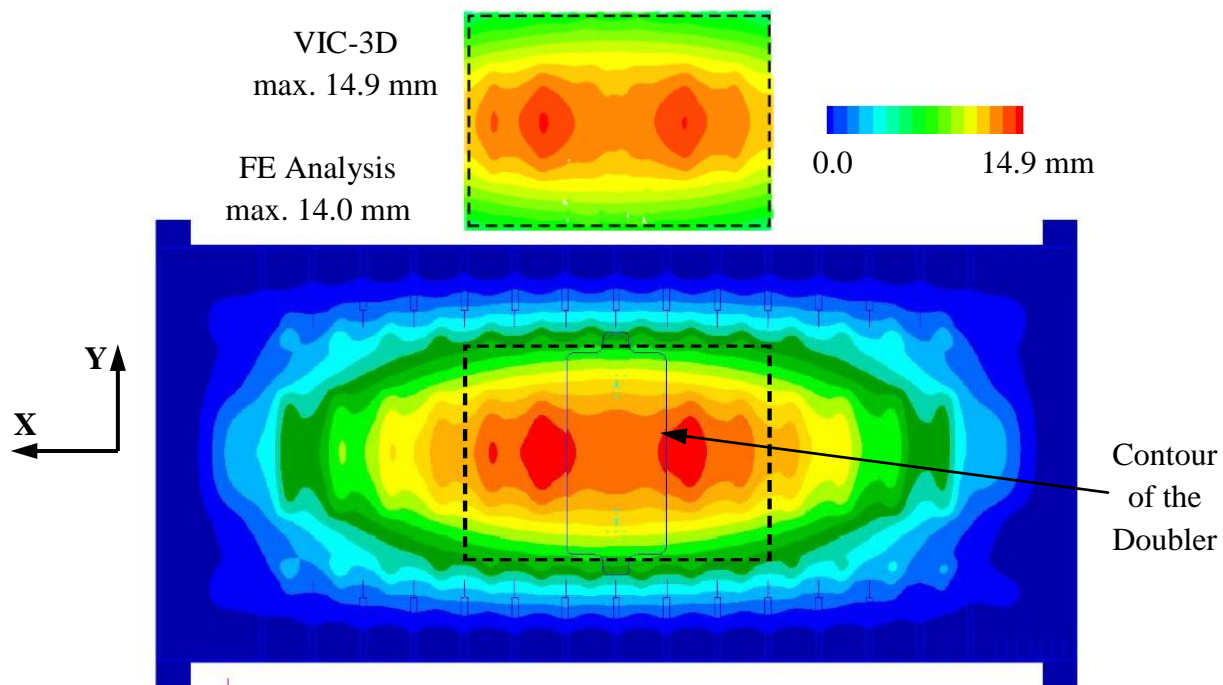
The VIC-3D out-of-plane displacement fields acquired in the center section of the panel described in section 3.1 were compared with the corresponding FE analysis results. Comparisons conducted at the DLL of 63.43 kPa (9.2 psi), DUL of 126.86 kPa (18.4 psi), and DUL+10% of 139.55 kPa (20.24 psi) resulted in very similar quality agreement. Therefore, only the DUL case is shown in Figure 11. The top section of the plot presents the entire VIC-3D speckle pattern area. The bottom section presents the solution for the entire FE model and the corresponding area is indicated with a dashed line. The maximum displacement occurs in skin sections away from the panel center since the center of the panel is stiffened by the repair. Overall, the qualitative shape comparison is very good and the maximum displacement from the analysis exceeds the measurement by only 6%.

Figure 11. Out-of-plane displacement at DUL of 126.86 kPa (18.4 psi).

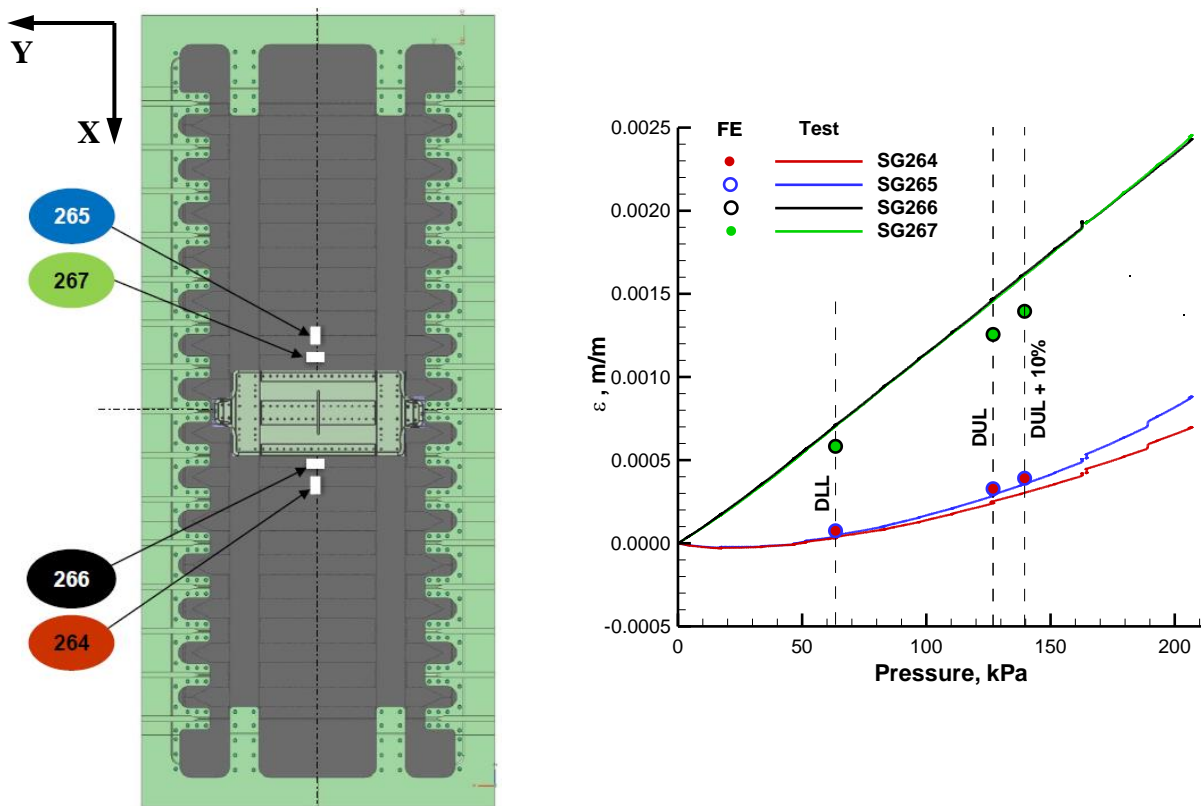
Results obtained at selected gage locations are presented next to assess strain correlations obtained in distinct sections of the repaired panel. Specifically, results obtained on the composite panel are shown in Figure 12, on the repair doubler in Figure 13, and on the repair angles in Figure 14. In each plot the test results are shown as solid lines as the pressure was increased, while the FE results are shown as the same color circles only at the three pressure levels introduced at the beginning of this section. All the comparisons are generally favorable. In the composite panel (Figure 12) strains measured in the X-direction by the red and blue curves are captured very accurately by the analysis, and transition from a slight compression below approximately the DLL of 63.43 kPa to a slight tension above this level. Strains in the Y-direction by the black and green curves exhibit nearly linear behavior in tension. The analysis accurately captures the linear trend but tends to slightly under-predict the strain values.

Figure 12. Strains on the smooth side of the composite panel near the doubler.

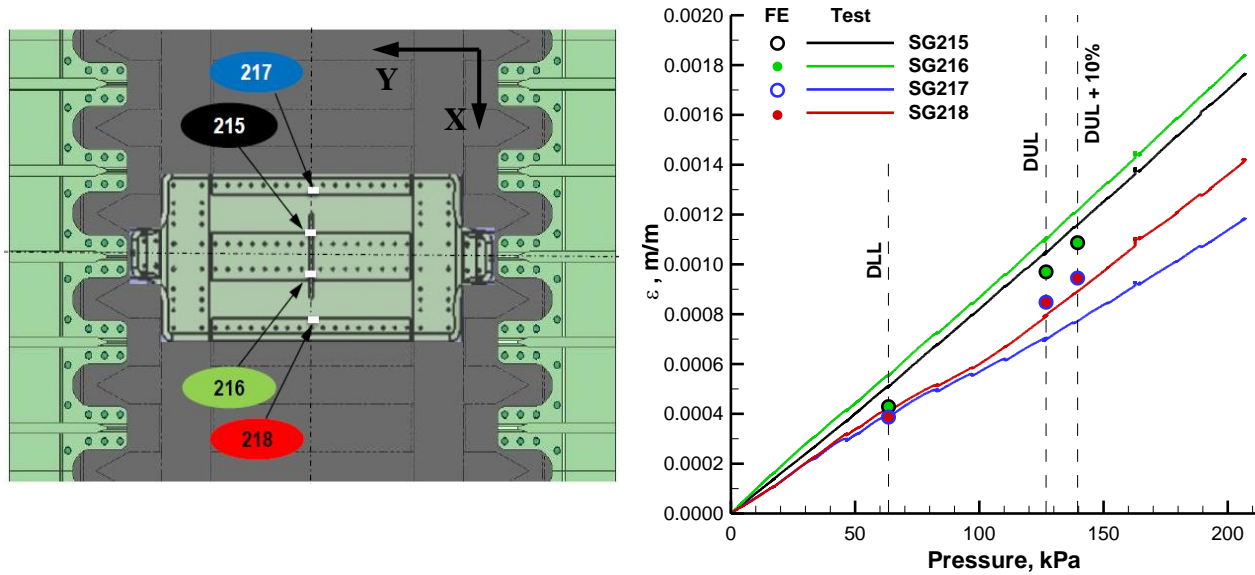
Strains measured near the center of the doubler (Figure 13) also show linear characteristics and the trend is accurately captured by the analysis, although again the analysis tends to under-predict the measurements. Note that the analysis assumes a symmetric test article while the measured data is not exactly symmetric. Both doubler edge gages show slight nonlinearities in measurements that are not captured in the analysis. Since slight discontinuities are visible in the measured data, a settling of the repair is suspected and it may be amplified by single-shear fasteners as no inner repair components extend to those locations. The settling appears to be more pronounced on one side of the strap than the other.

Figure 13. Strains in the repair doubler.

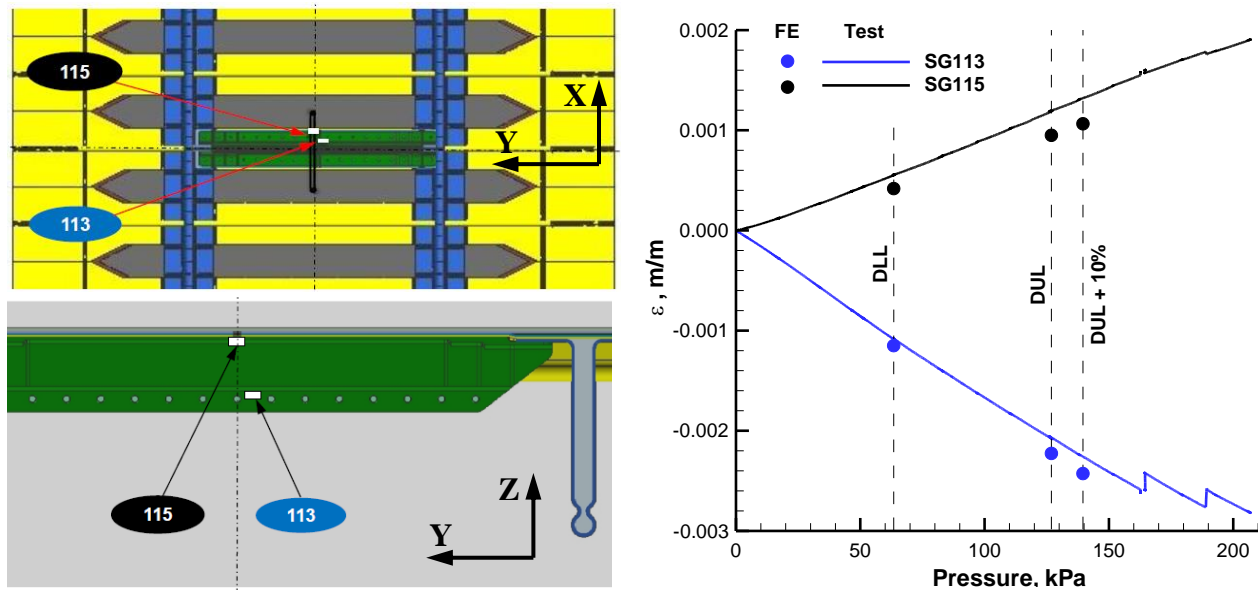
Finally, the strains on the inner repair angle are compared in Figure 14. Since this location is dominated by bending in the positive Z-direction, strains in the repair flange are in tension as shown by the black curve, and strains at the tip of the angle's web are in compression, as shown by the blue curve. The two measurements are captured accurately by the analysis, however, the tension is slightly under-predicted and compression is slightly over-predicted. This combination may be indicative of the fact that the actual neutral bending axis in the panel was located further away from the panel surface than in the FE model. Note that installation imperfections, such as a liquid shim applied between the repaired stringer flange and the repair's angle flange, were not considered in the FE model. This shim thickness might contribute to the neutral bending axis misalignment between the test article and the FE model.

Figure 14. Strains in the repair angle.

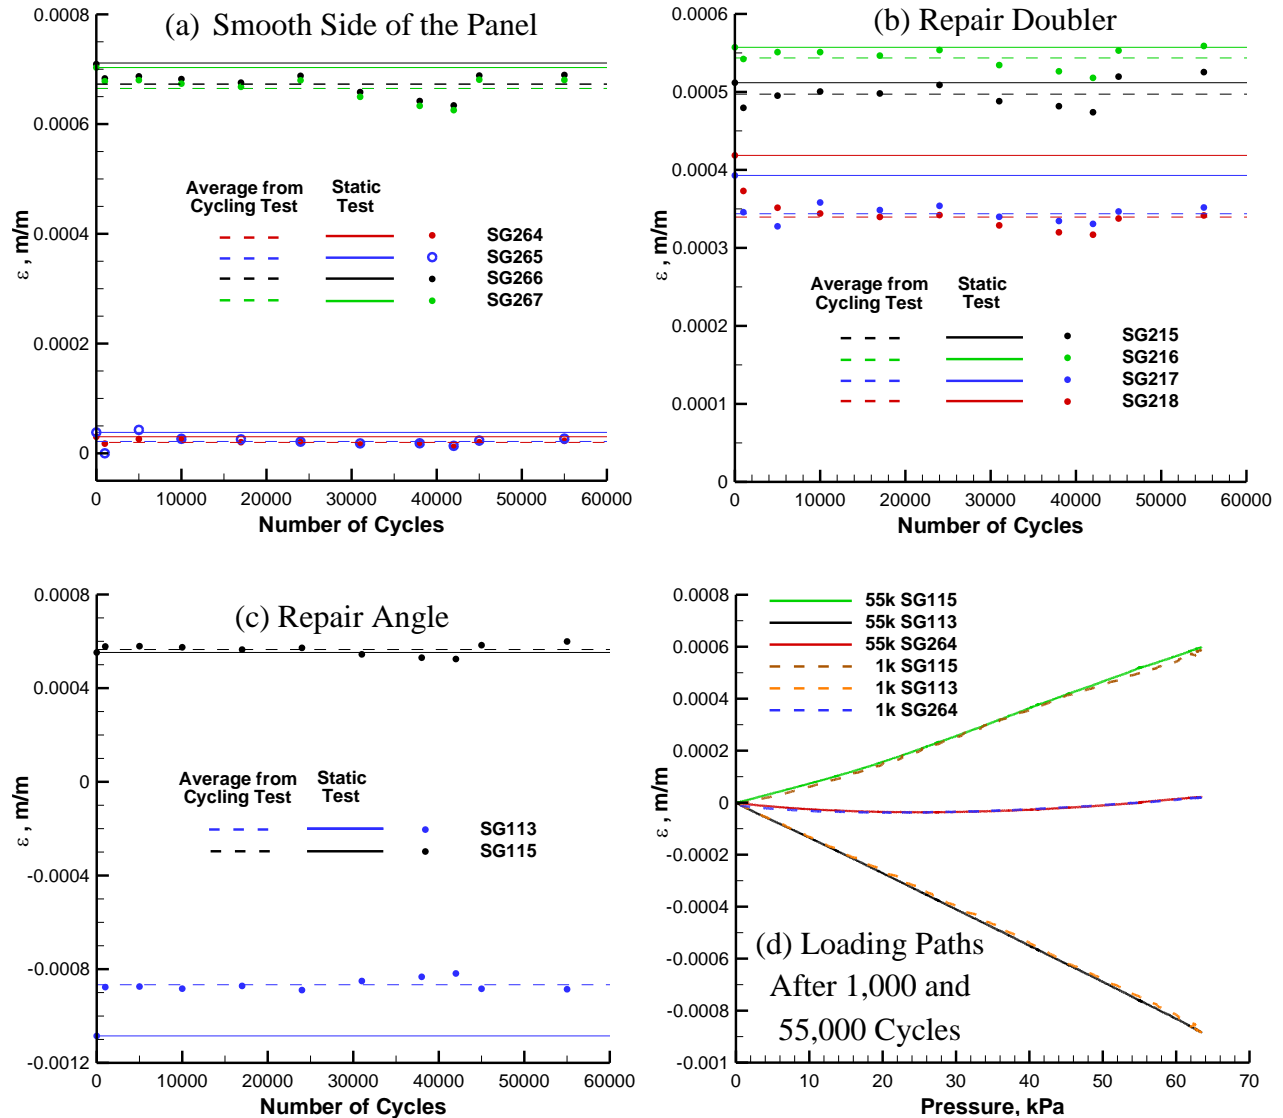
The repaired pressure panel was subjected to the total of 55,000 DLL pressure cycles. Strains measured by the same gages used in the static test were recorded during one full pressure cycle upon completion of 1,000, 10,000, 17,000, 24,000, 31,000, 38,000, 42,000, 45,000 and 55,000 cycles. Strains at the DLL pressure as a function of the number of completed cycles are presented in Figure 15(a)-(c) for the same selected gages discussed in the static test analysis in section 3.3. The same grouping of results as in Figures 12-14 is maintained. Solid lines in Figure 15(a)-(c) correspond to the static test values and dashed lines correspond to the average values obtained from the 10 recordings obtained during the fatigue test cycling. Only small deviations of the cyclic data points from their corresponding averages are seen and there are no appreciable trends observed in the strain responses as the number of cycles was increased that would indicate possible deterioration of structural integrity. However, for nine out of 10 strain measurements considered, the static test produced a larger absolute strain value than the cyclic average. This difference can be explained by a settling process when the initial cycle or a few initial cycles involve some strain hysteresis. This behavior is most evident in the gage shown in blue in Figure 15(c) which was at the tip of the repair flange where the two metallic repair angles were pre-assembled together before being mounted onto the panel. This installation sequence

may have resulted in residual stresses between the two angles being released in the few initial load cycles. Settling trends are also very prominent at two gages in the proximity of single-shear fasteners, shown as blue and red points in Figure 15(b), which can also be a factor promoting the initial settling.

Measured strains as a function of pressure up to the DLL after 1,000 and 55,000 cycles are shown in Figure 15(d) for selected gages on the repair angle and the smooth side of the panel. The data confirms that the pressure-strain curves at the beginning and at the end of the cyclic pressure test match closely indicating no significant changes in the mechanics of the structure.

Figure 15. Strains: (a-c) at the DLL pressure as a function of number of cycles, (d) as a function of pressure at 1,000 and 55,000 cycles.
